TRANSPORTATION RESEARCH CENTER

ON-SITE AIR BAG INVESTIGATION

CASE NO. - 94-09

**U.S. Department of Transportation
National Highway Traffic Safety Administration
National Center for Statistics and Analysis
Washington, D.C. 20590**

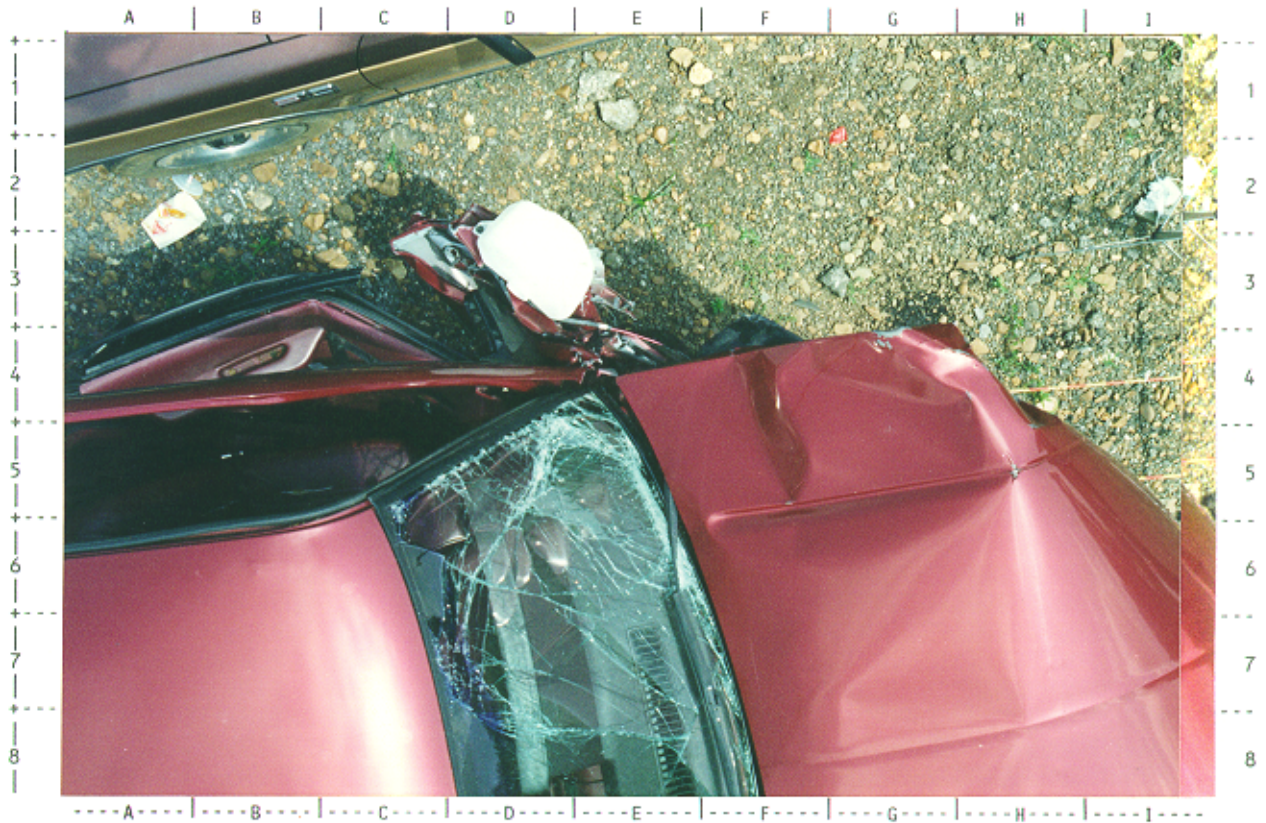
66 -- Front left close-up of damage to 1988 Chevrolet pickup; NOTE: damage to FL hood, LF wheel, & continuation along left side

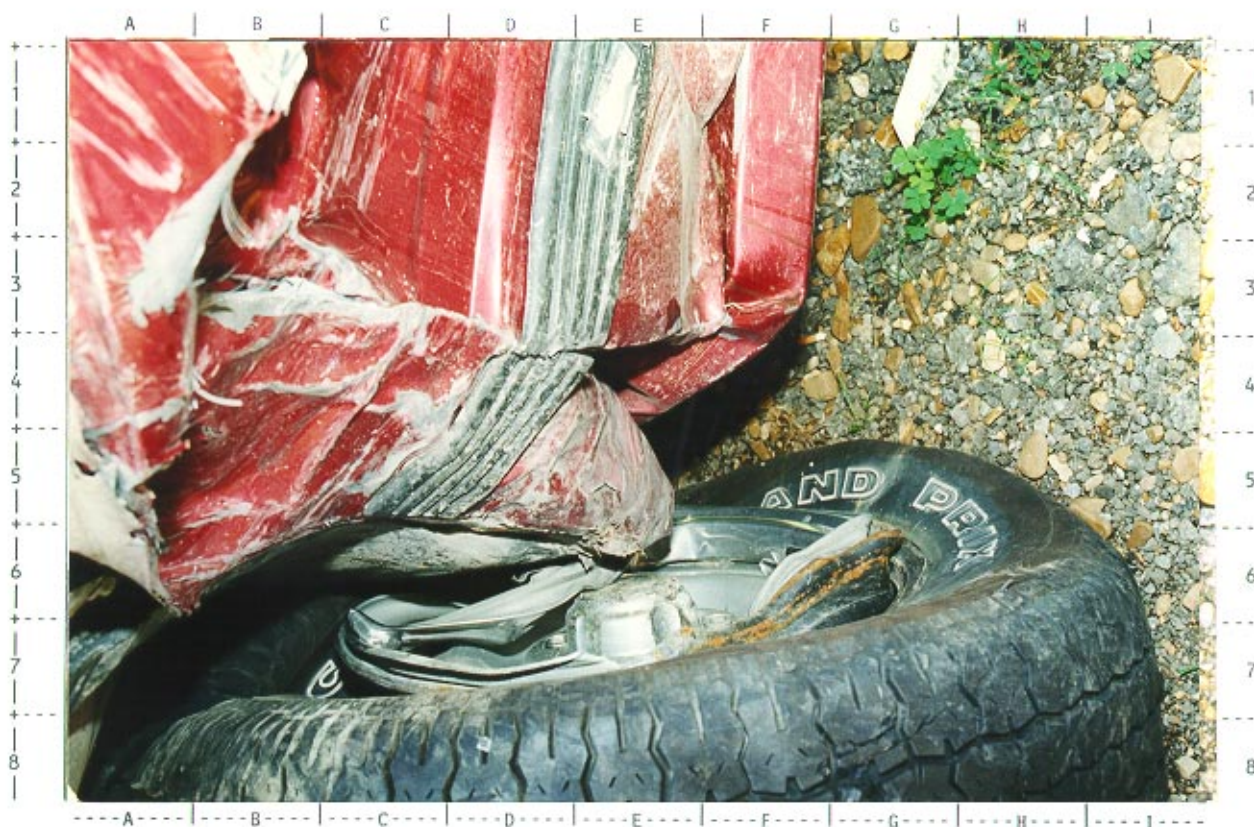
68 -- Close-up of 1988 Chevrolet pickup's left front wheel damage; NOTE: broken steering rod and grass & mud in wheel rim

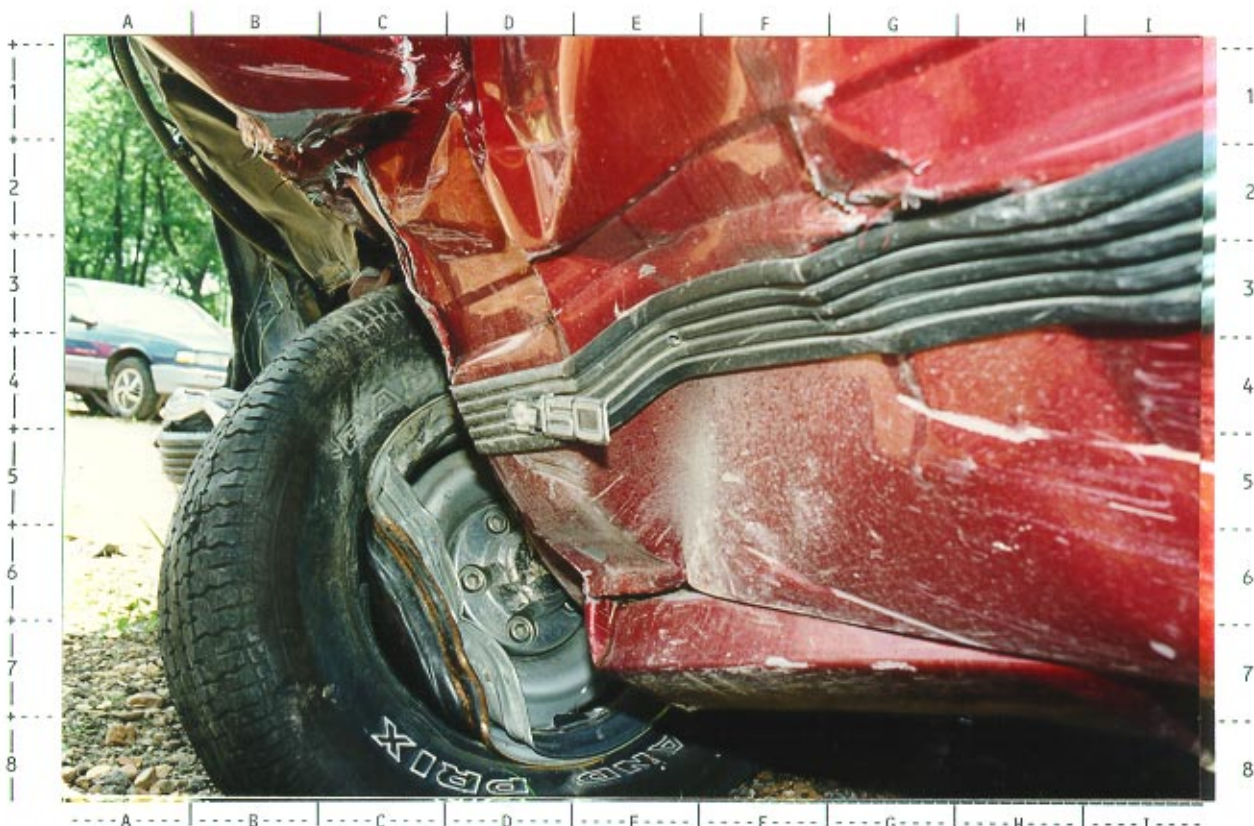
69 -- Close-up of direct damage to 1988 Chevrolet pickup's LF rim and also behind displaced left front wheel--viewed from left

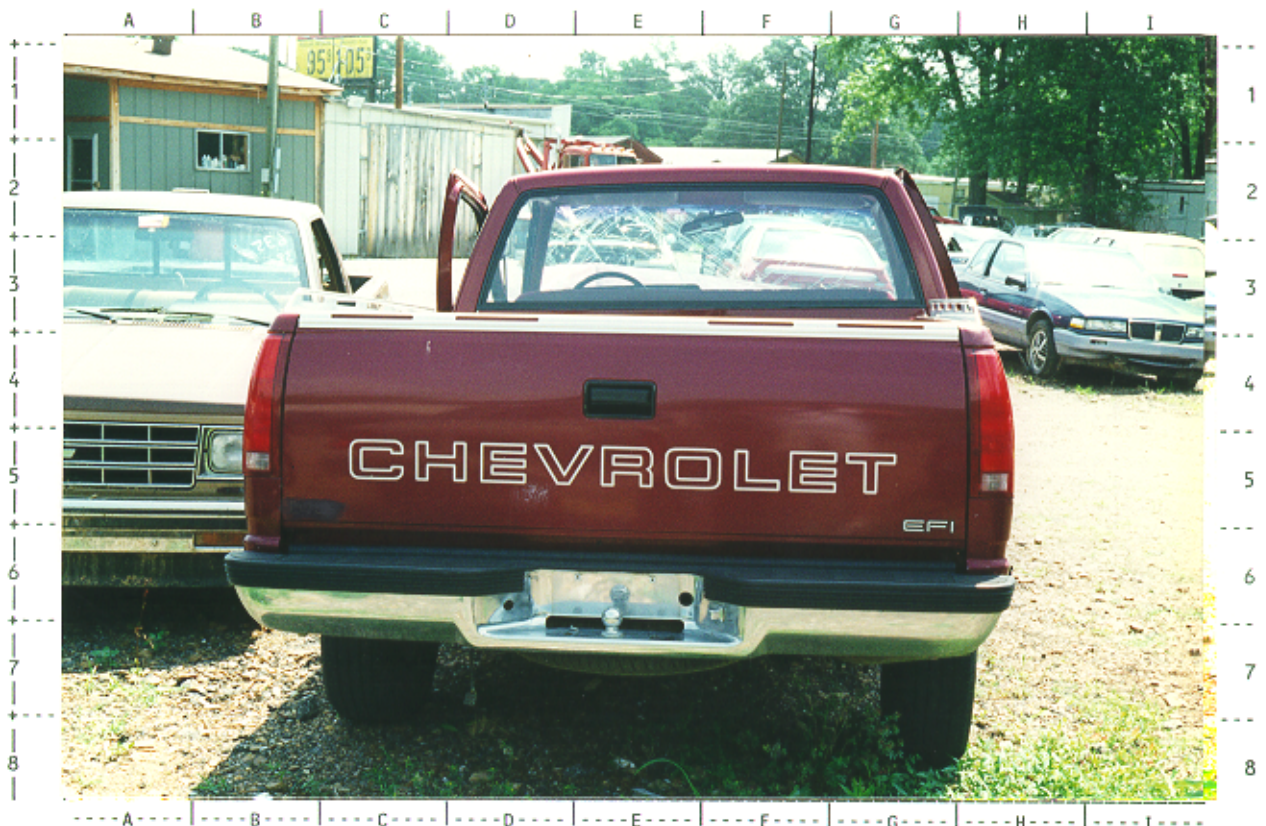
73 -- Left side reference line viewed from back shows frontal damaged to 1988 Chevrolet pickup; NOTE: undamaged back left corner

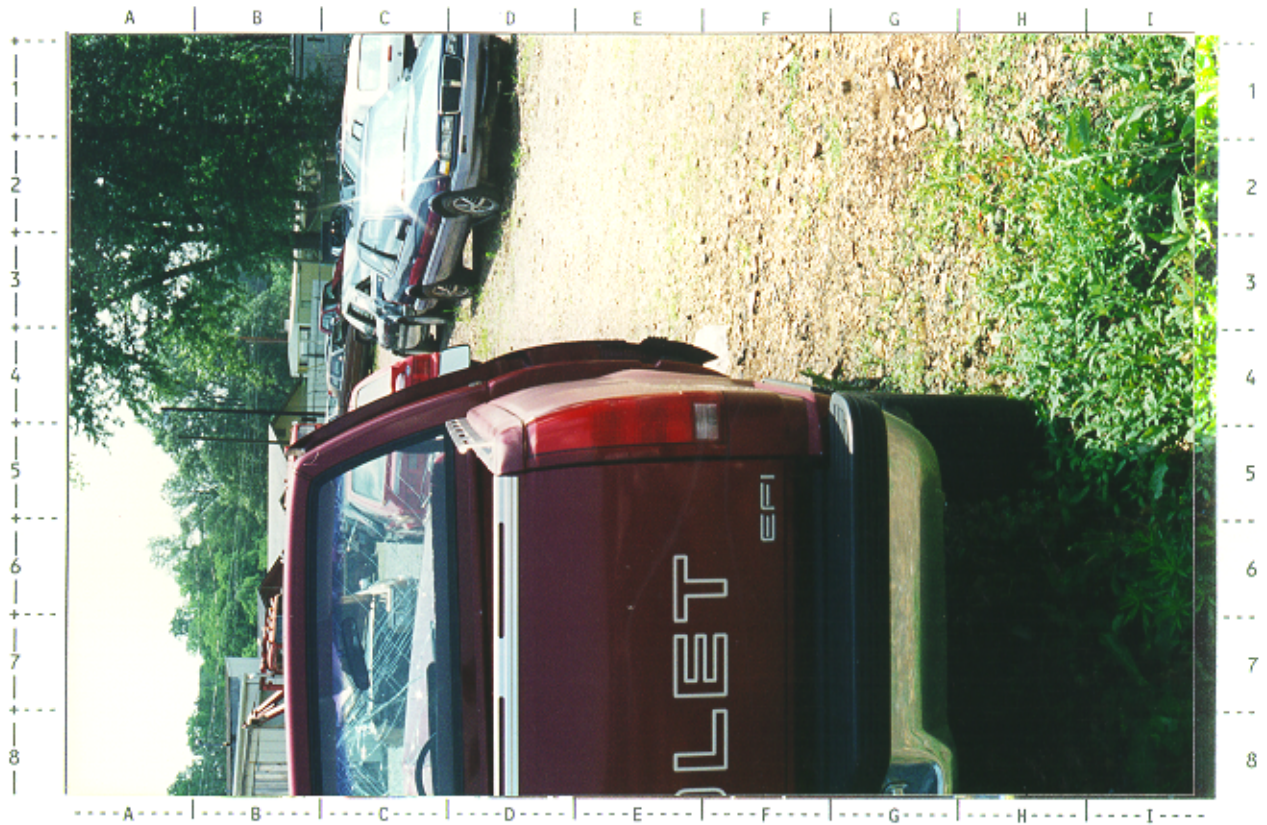
74 -- Back view of 1988 Chevrolet C-1500 pickup showing undamaged back side; NOTE: driver's door window frame is bent outwards

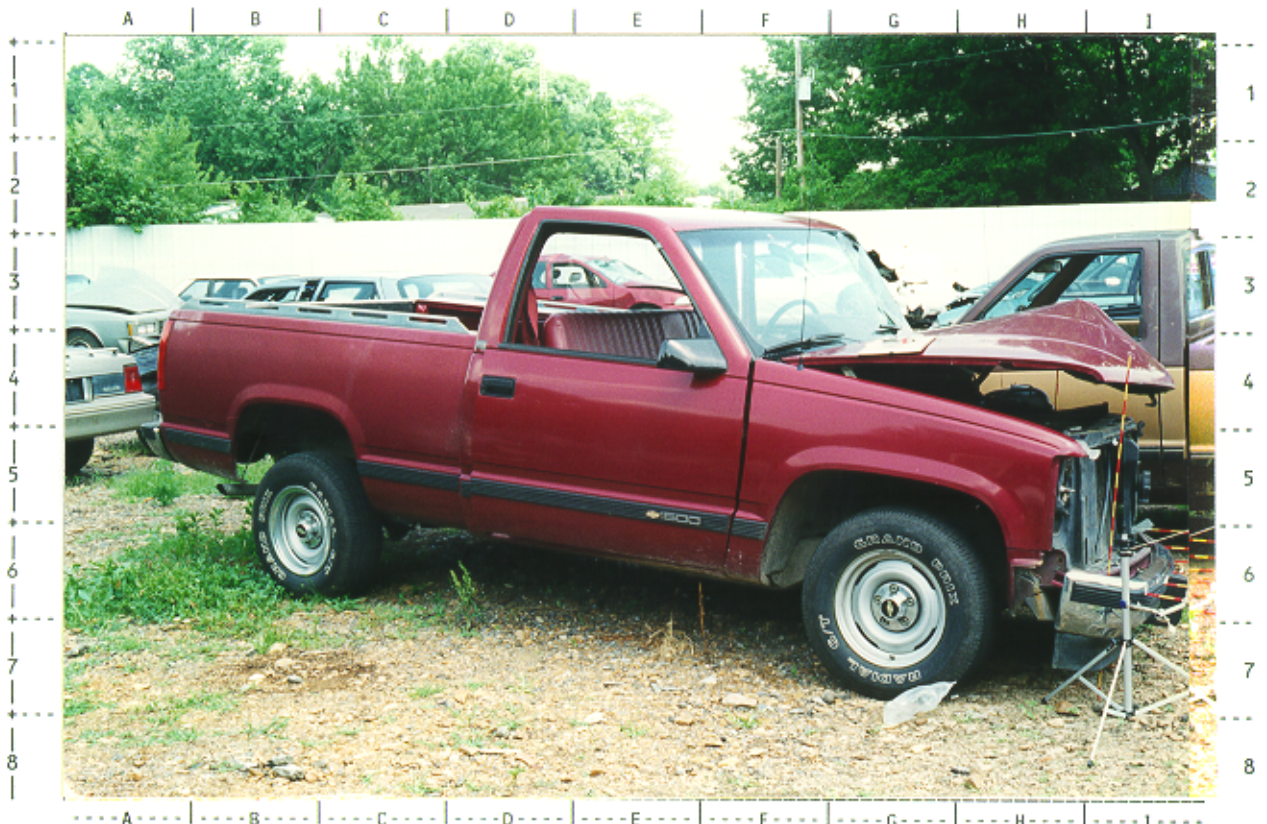
75 -- Right side reference line viewed from back shows induced damage to 1988 Chevrolet pickup; NOTE: shift between cab & cargo box

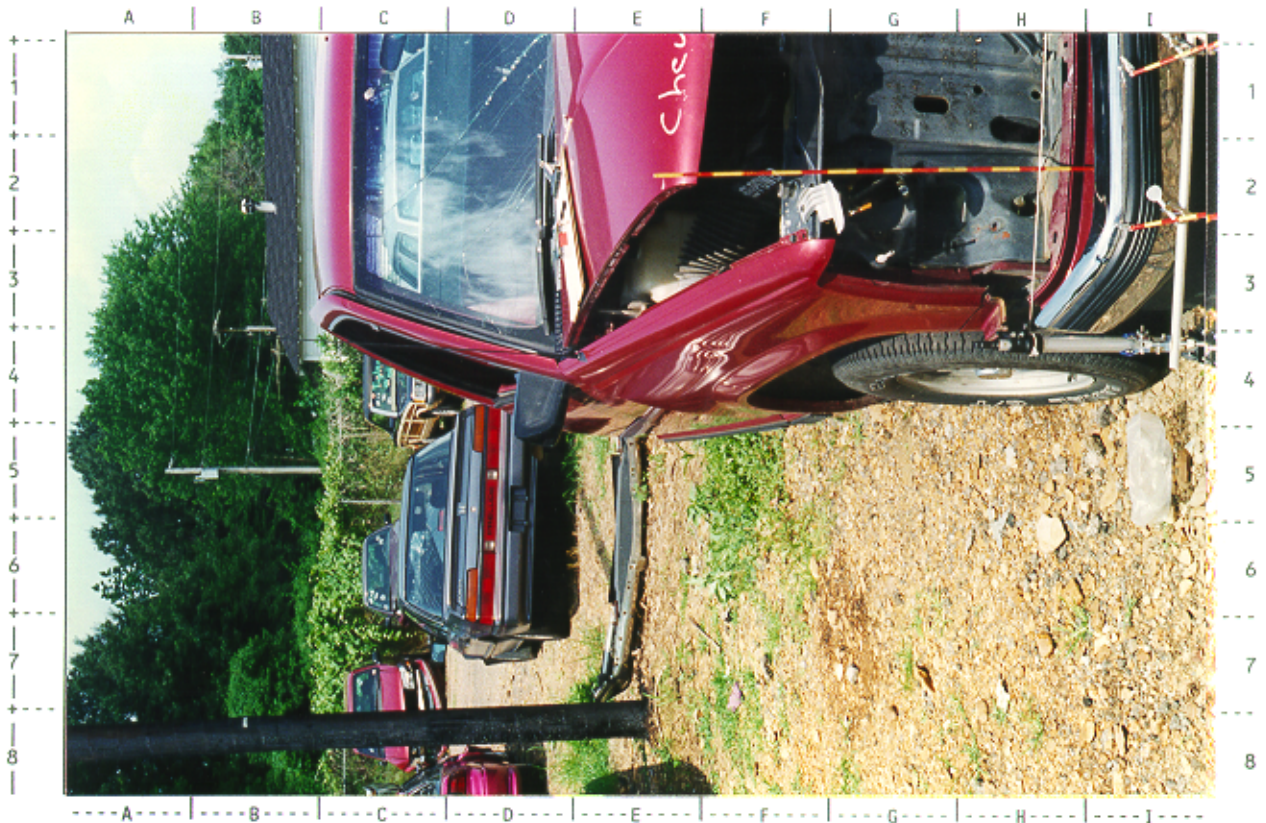
76 -- Right side view of 1988 Chevrolet C-1500 pickup showing undamaged right side except for induced damage to right front door

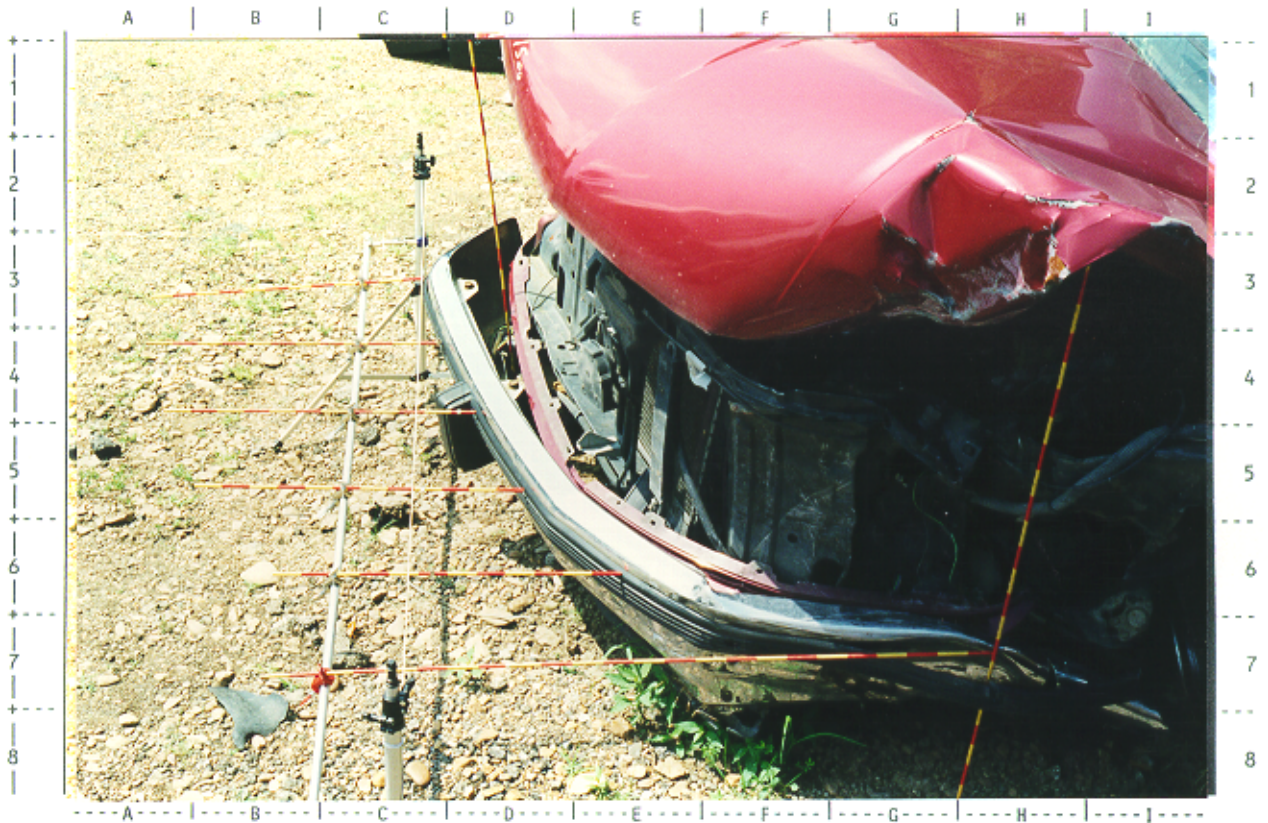
78 -- Front reference line viewed from R with contour gauge present shows damage to front left corner of '88 Chevrolet C-1500 pickup

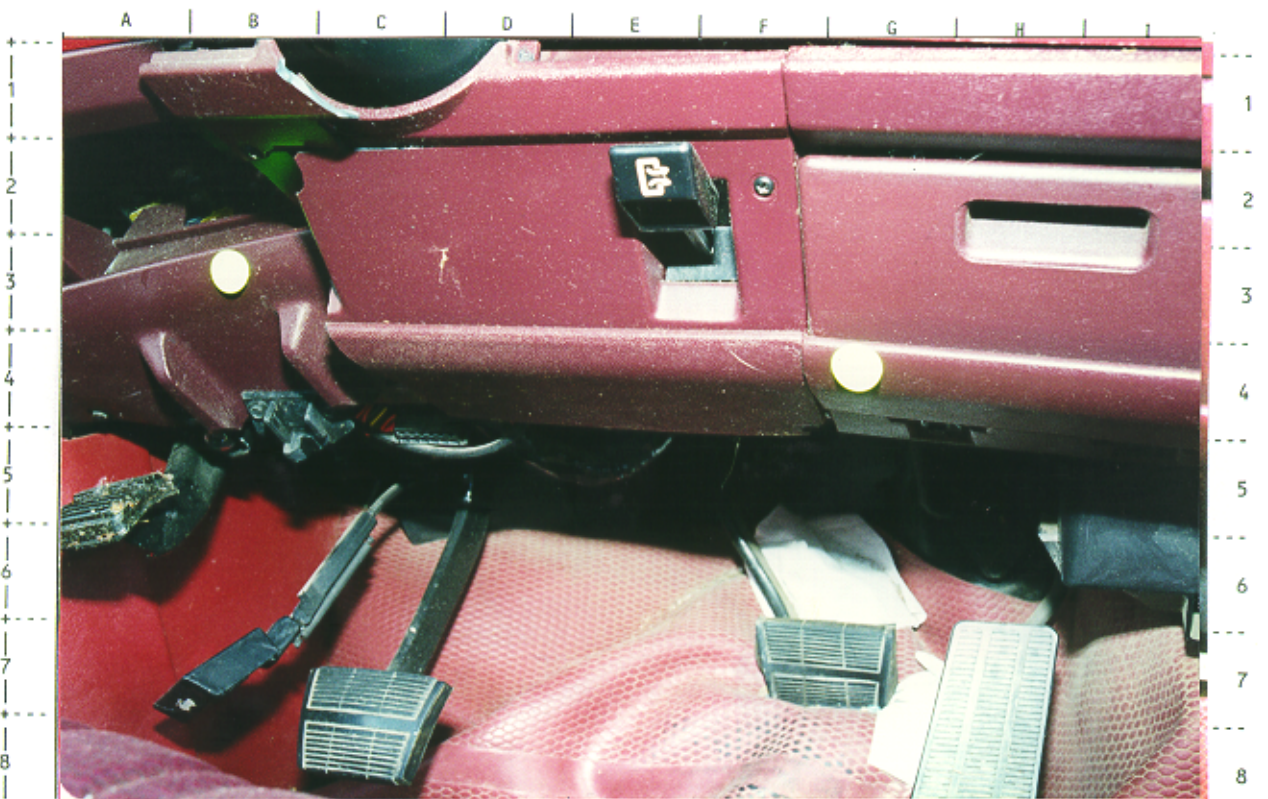
82 -- Close-up of contacts to 1988 Chevrolet pickup's lower dash from driver's knees; NOTE: entrapment occurred in toepan area

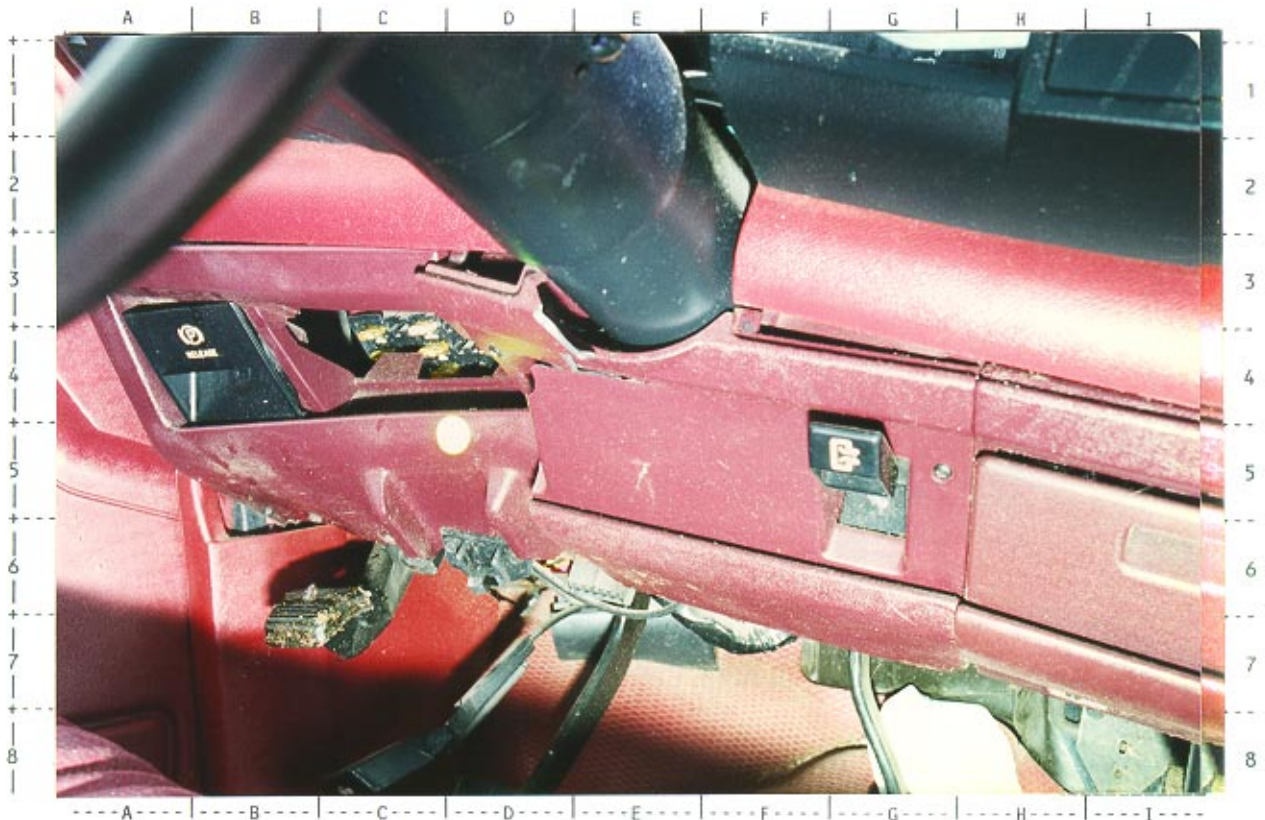
83 -- Close-up of left knee contact to 1988 Chevrolet pickup's left lower dash area; NOTE: entrapment occurred in toe pan area

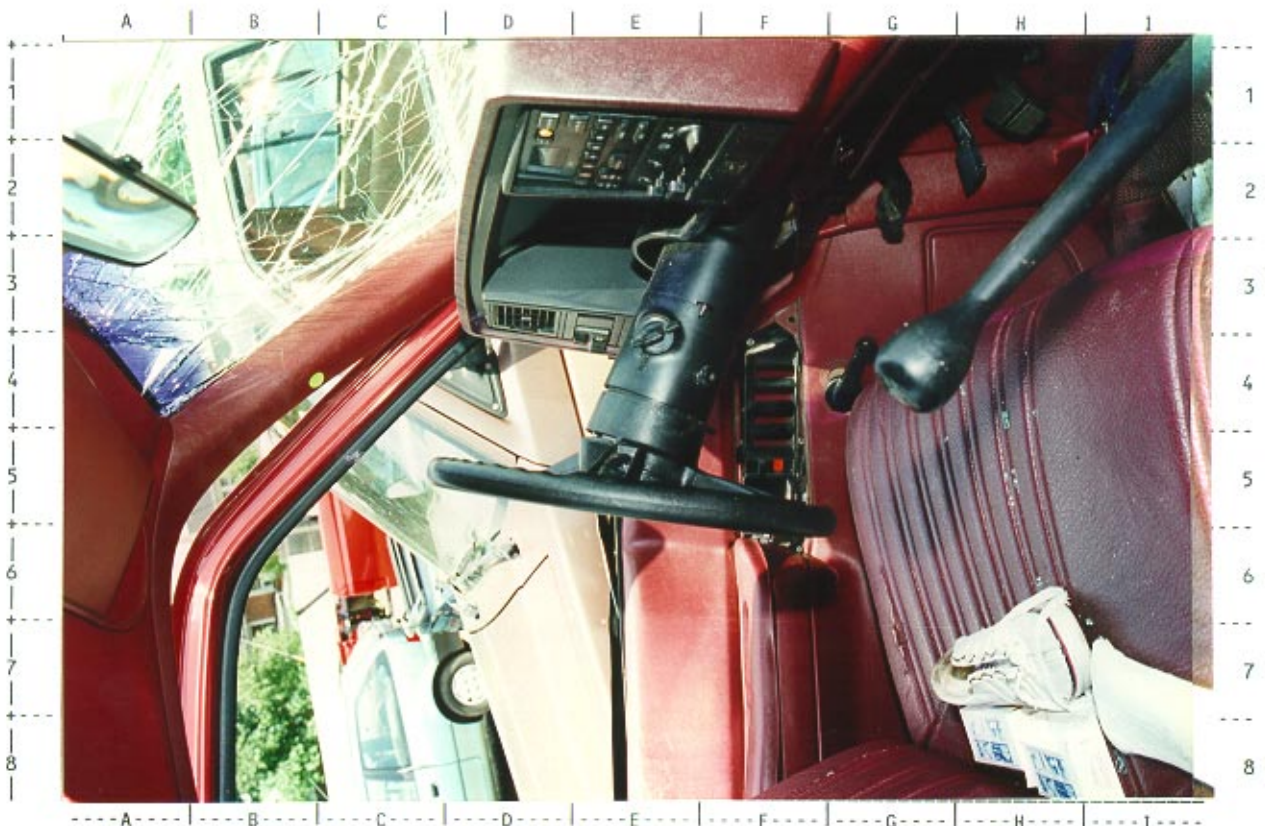
84 -- Deformed steering wheel in 1988 Chevrolet C-1500 pickup viewed from right front passenger side

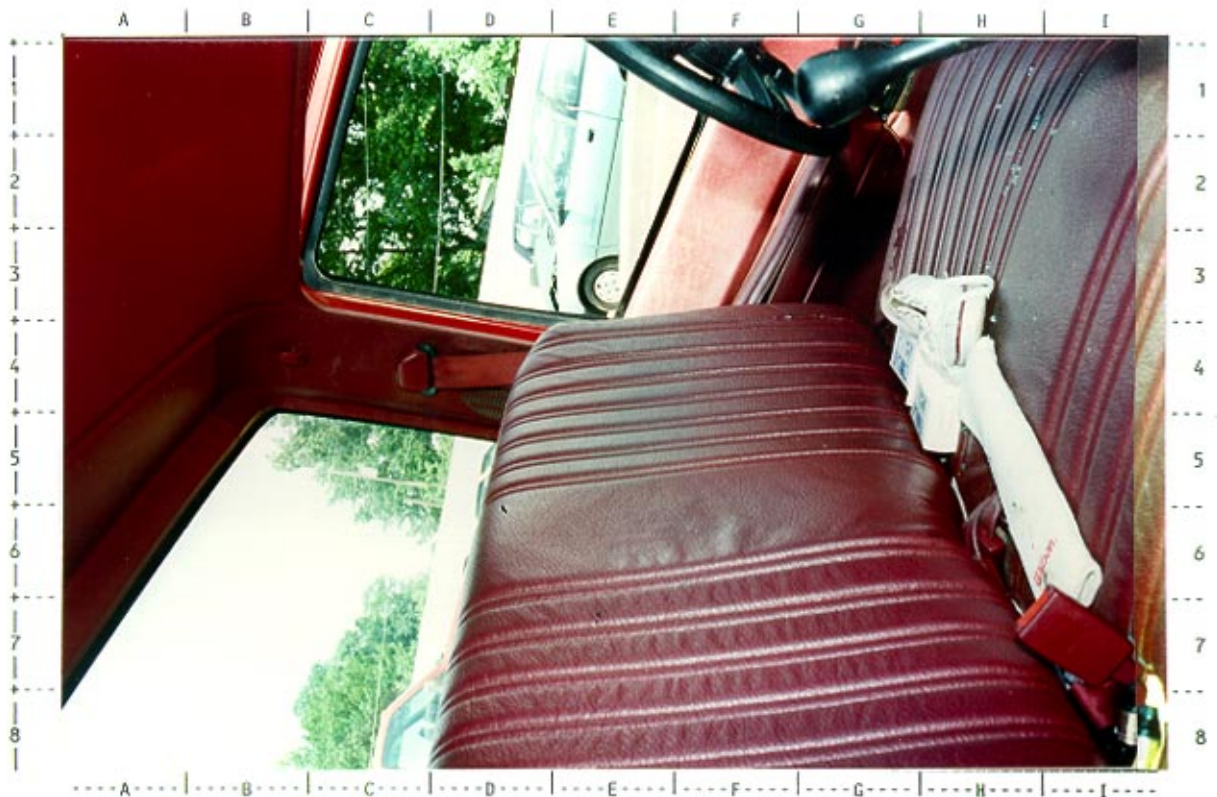
88 -- Interior view of driver's seating area of 1988 Chevrolet pickup;
NOTE: unused driver's 3-point lap and shoulder belt

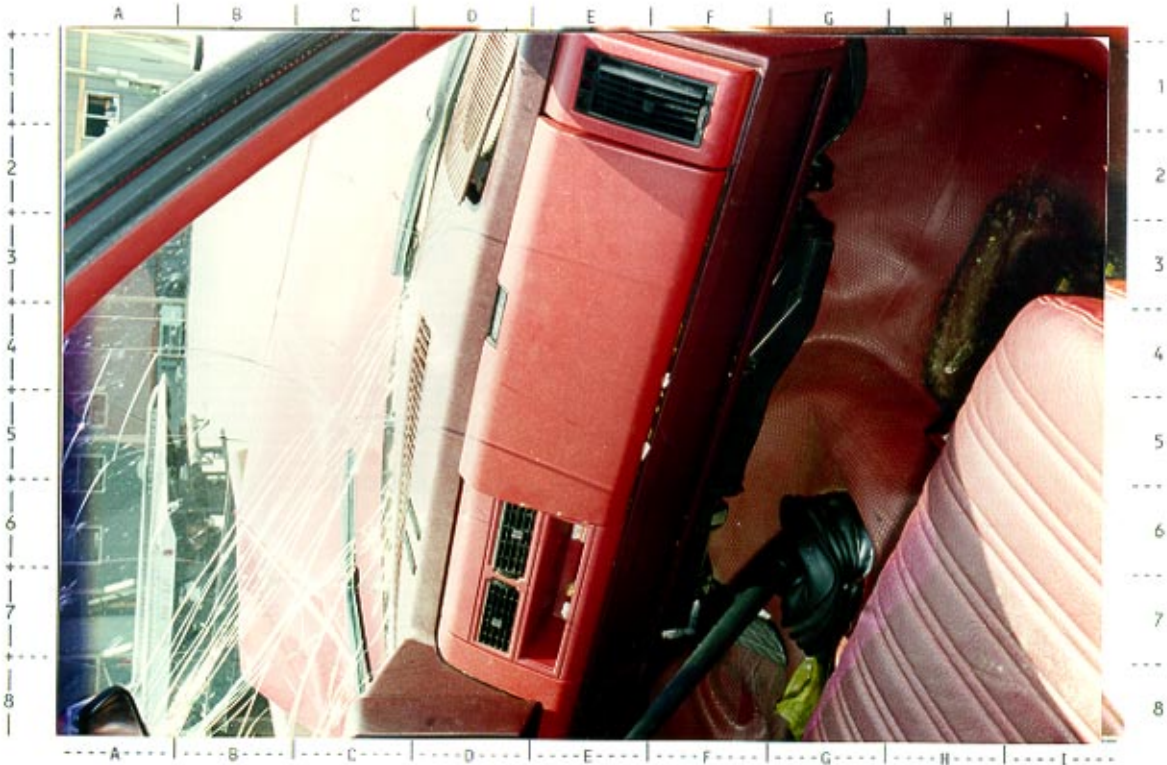
89 -- Front center & right dash areas of 1988 Chevrolet pickup; NOTE: undamaged dash and minor intrusion to toepan area

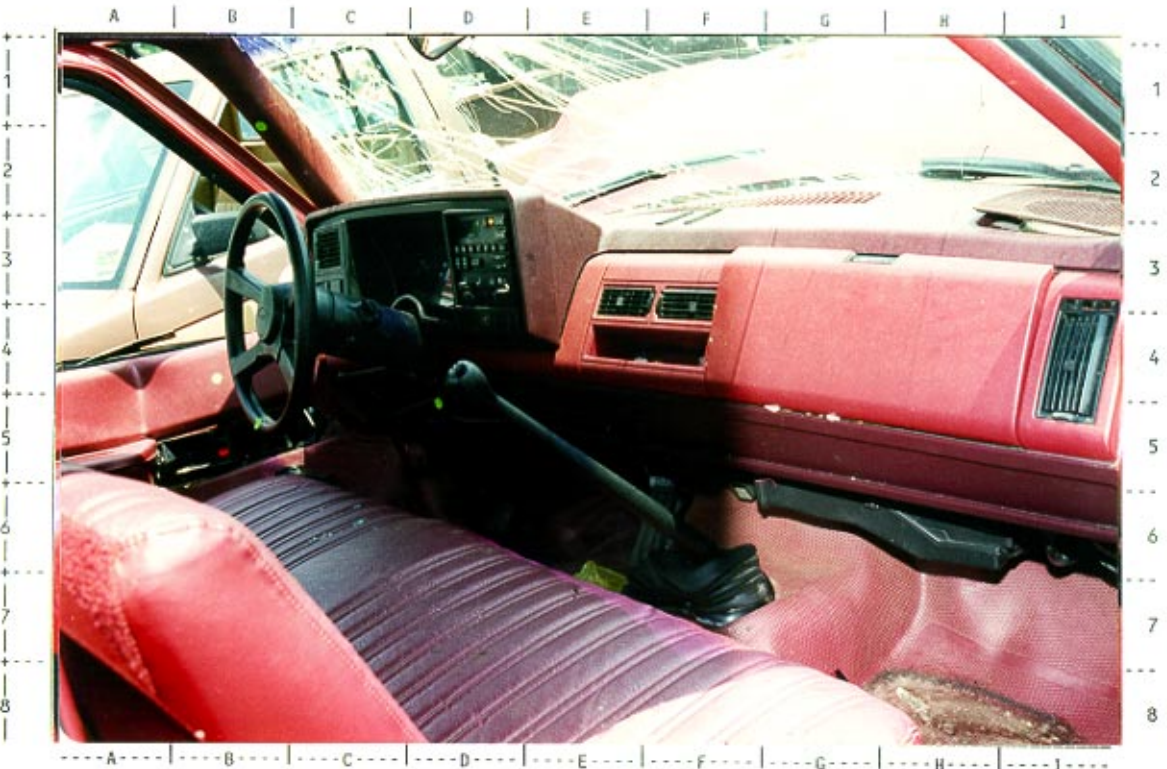
90 -- Steering wheel & dash of 1988 Chevrolet pickup viewed from right exterior; NOTE: evidence of driver contacts (dots) on left dash
